## 4.2 Analysis of pewter-clad studs sf 2363 and 2383 by Peter Northover

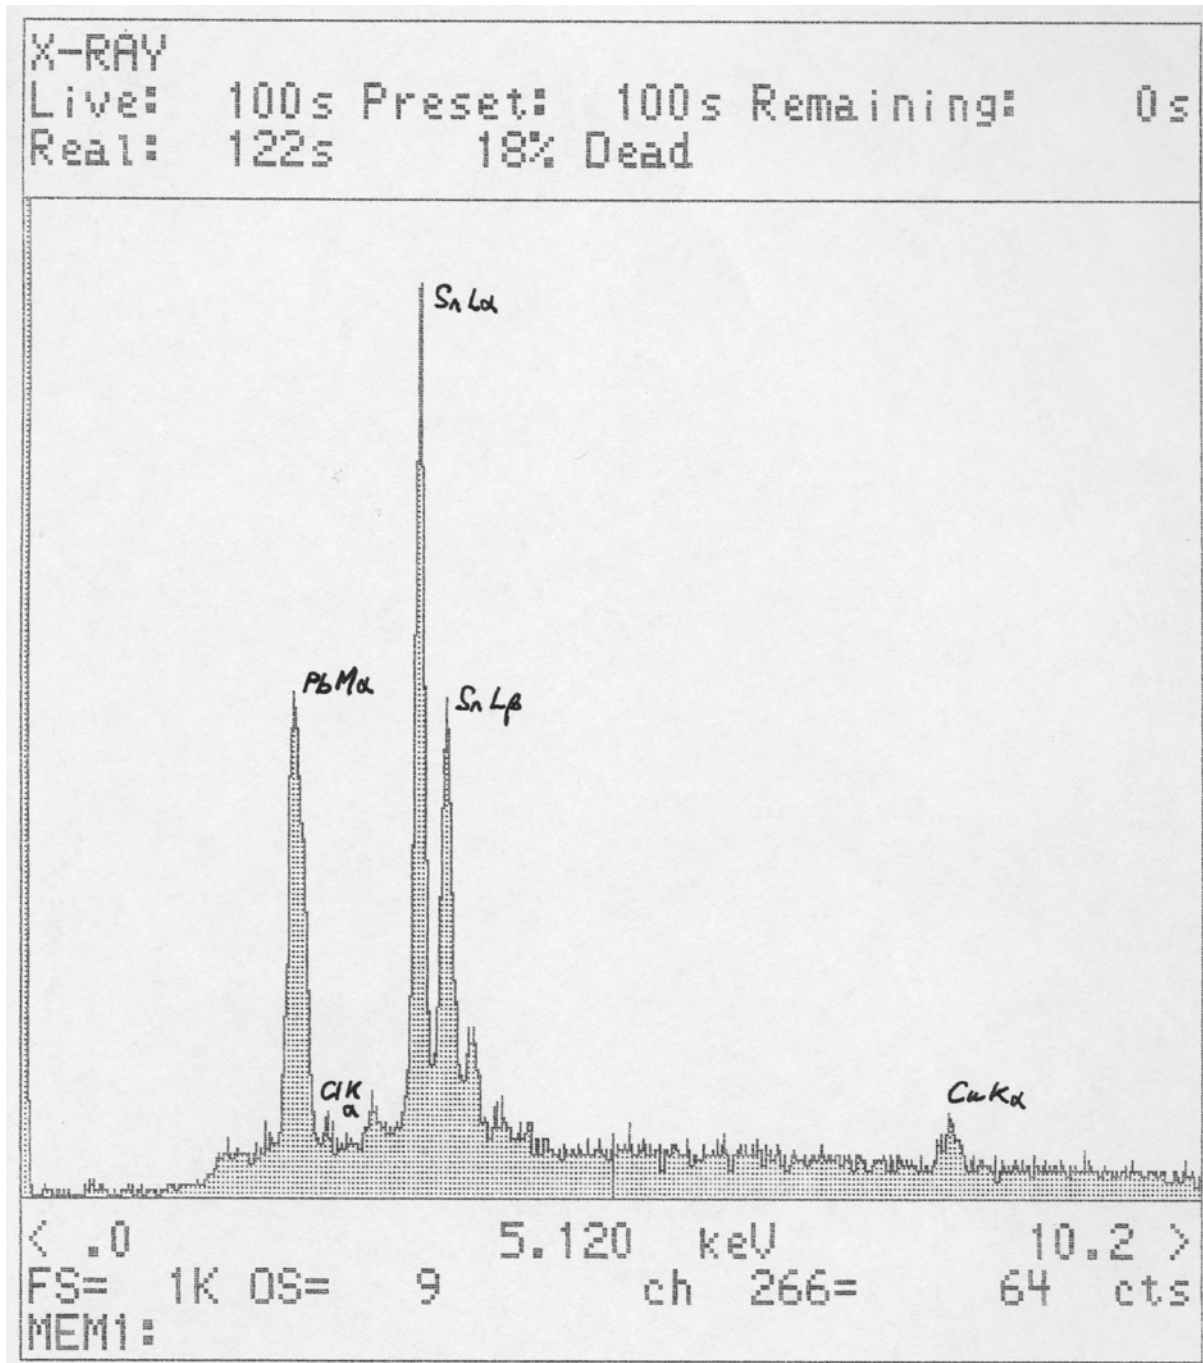
The great majority of the sample gave very similar X-ray spectra, a typical example of which is attached to this report. The principal variations were in the amount of copper, chlorine and earthy elements such as silicon present. The spectrum illustrated was chosen because it effectively shows just the metallic elements present – tin in the majority, lead, and a small amount of copper. The copper could have come from the penetration of the corroded sample by copper ions from another part of the stud, or by the presence of copper-tin intermetallics, formed either by copper diffusing into the lead-tin alloy if it was actually bonded to it, or by copper being a contaminant in the solder itself. The spectrum indicates an alloy like a lead-tin solder, but it is not possible to use the spectrum from the corroded metal to suggest the original Sn:Pb ratio as there are too many variables in the corrosion process.

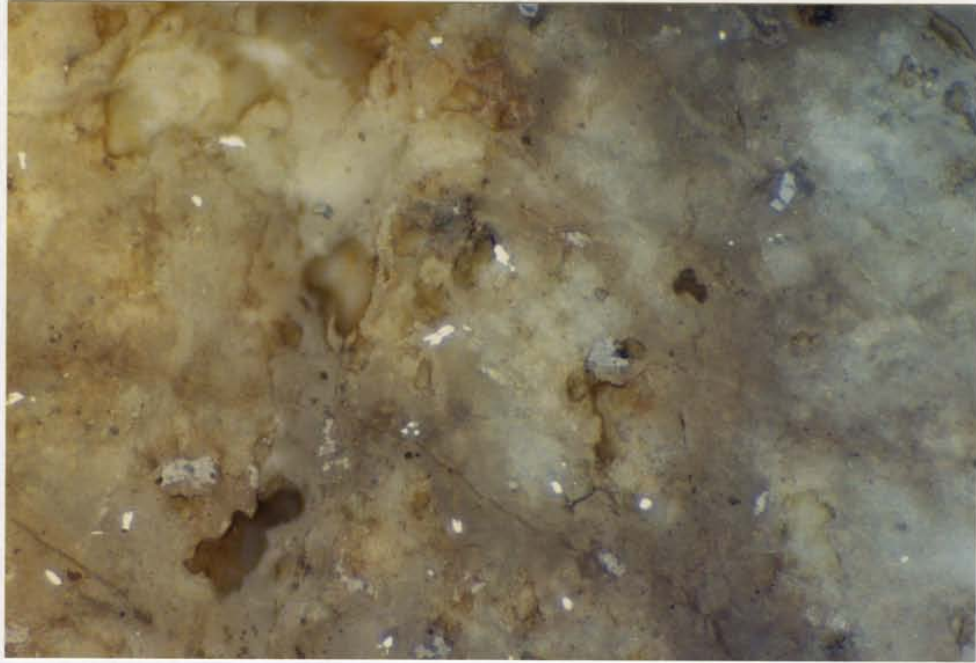
A typical area of the sample is illustrated in Figures 1 and 2 under normal incident illumination and under plane polarized light. The bulk of the sample exhibits a variety of shades of grey and brown from very pale to dark. This, in the writer's experience, is very typical of corroded pewter. The bright spots within the structure are uncorroded intermetallic compounds of tin with iron or copper impurities in the alloy. These intermetallics can be very resistant to corrosion; the nature of their occurrence suggests that the copper alloy could have been a cladding rather than a thermally bonded plating. In the latter case the interaction of the substrate with molten tin will produce a complete corrosion-resistant layer of intermetallics and this appeared to be absent in this case.

Fig. 1: #R1842, general view of corroded material with uncorroded intermetallic and (?)sulphide inclusions, unetched, x625

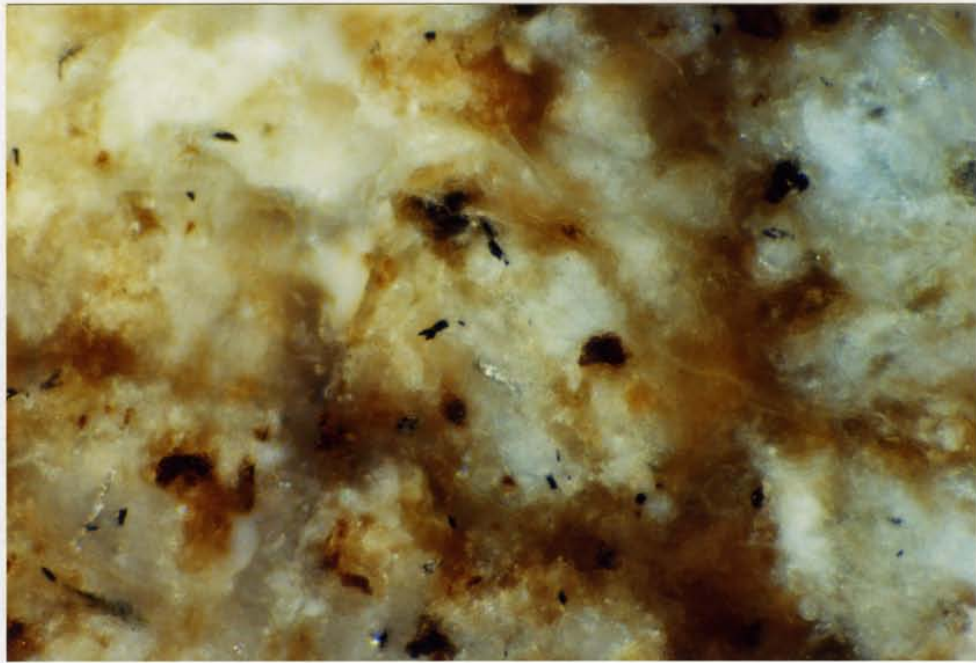
Fig. 2: #R1842, as Fig. 1 but viewed under plane polarised light; unetched, x625
